PENNSYLVANIA **LEVEL**
SHANGRI-LA DAM

NDI-PA 00248

PHASE I INSPECTION REPORT
NATIONAL DAM INSPECTION PROGRAM

Name of Dam: Shangri-La Dam ID #PA00248
State Located: Pennsylvania
County Located: Chester
Stream: Broad Run
Coordinates: Latitude $39^{\circ} 47.0'$, Longitude $75^{\circ} 44.4'$
Date of Inspection: (June 12, 1979),

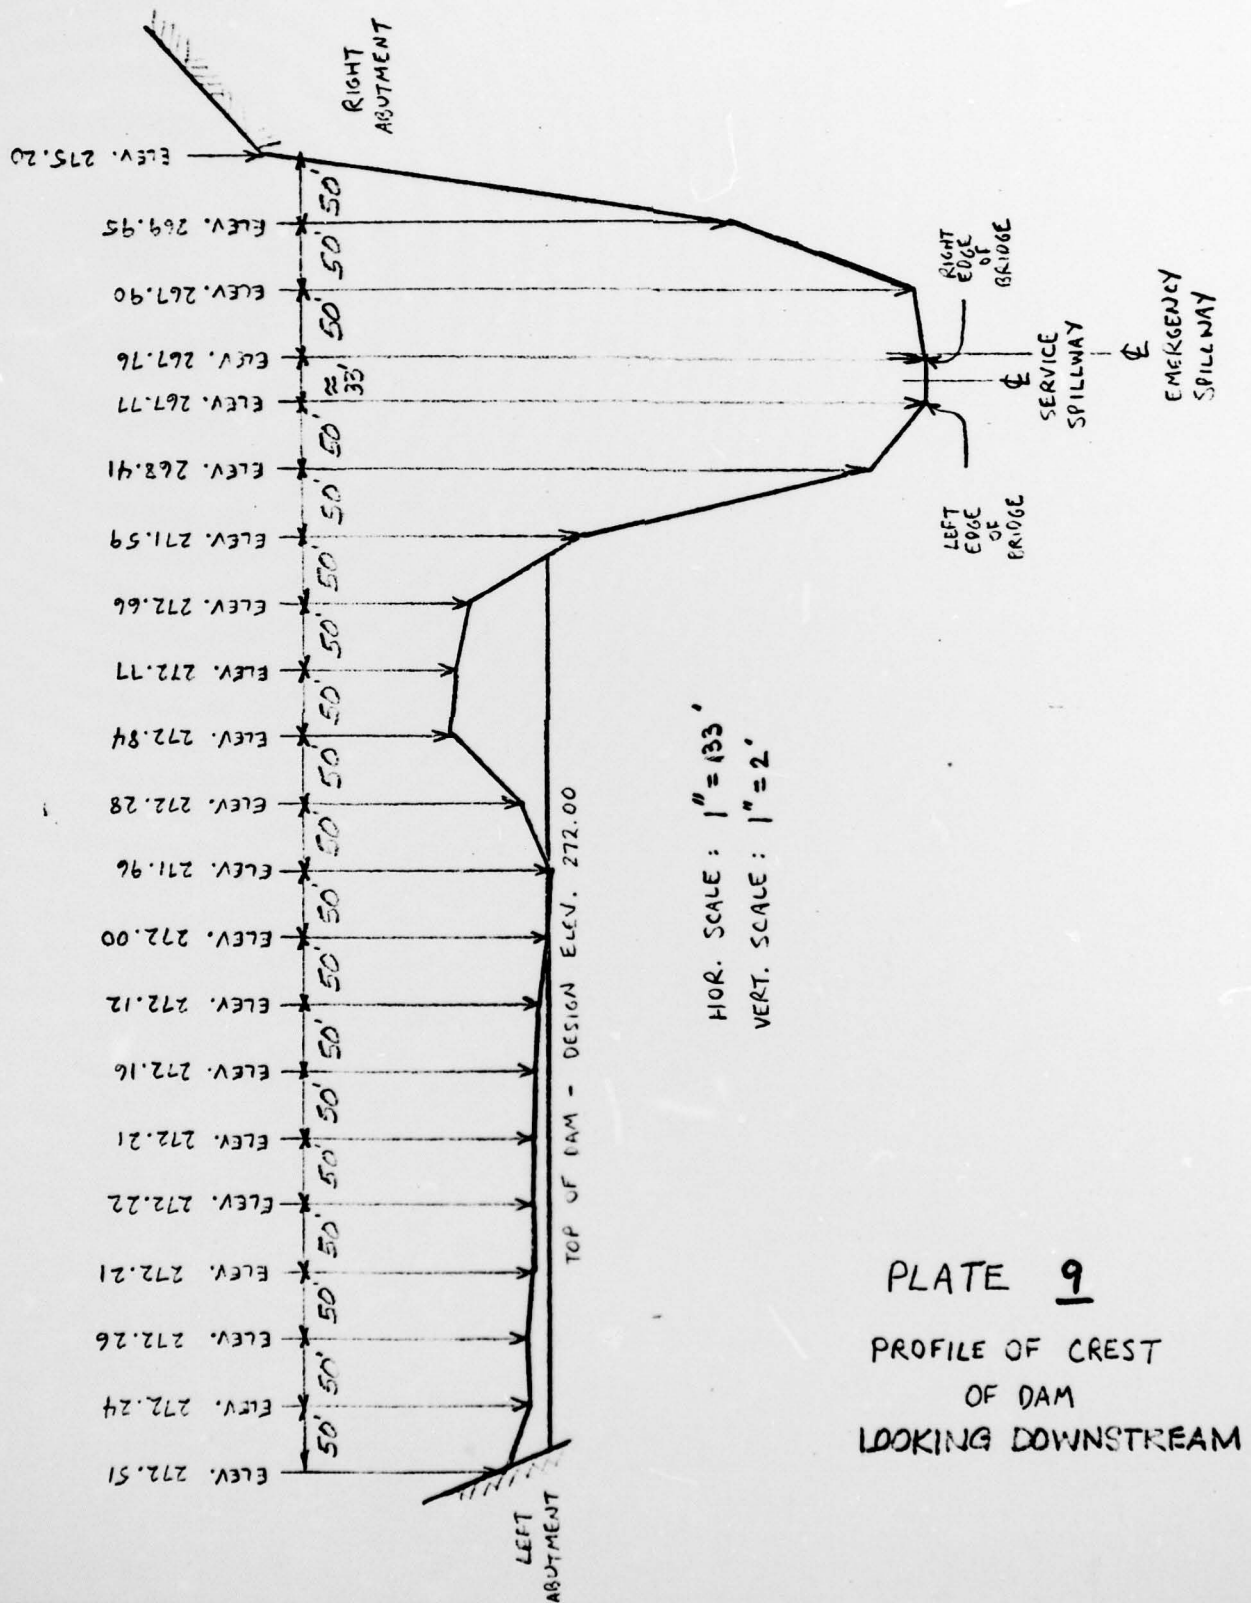
PLATE 9
PROFILE OF CREST
OF DAM
LOOKING DOWNSTREAM

The design drawings indicate that the knoll located immediately to the left of the emergency spillway was to be cut to the top of dam design elevation (Elev. 272.0). However, the survey of the dam crest revealed that the knoll ranges from 8 to 10 inches above design elevation (see Plate 9 in Appendix E).
